Investigation report

Leakage testing of coal seam gas wells in the Tara 'rural residential estates' vicinity

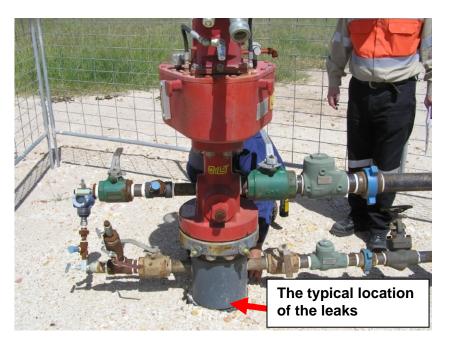
All leaks represent extremely low level concentrations of methane. These minor leaks were detectable on the well heads only when the detector was held immediately hard up against the well head equipment. There were no methane gas readings detected at a distance of approximately half a metre away from any of the well heads checked.

Photo of a typical well head – majority of the detected gas readings were recorded at the threaded connection between the steel casing pipe and the well head base at ground level (see red arrow).
